Date: June 6, 2022
Applicability: PowerDrive
Issued By: David Smith, Operations Manager
Approved By: David Smith, Operations Manager

BACKGROUND INFORMATION

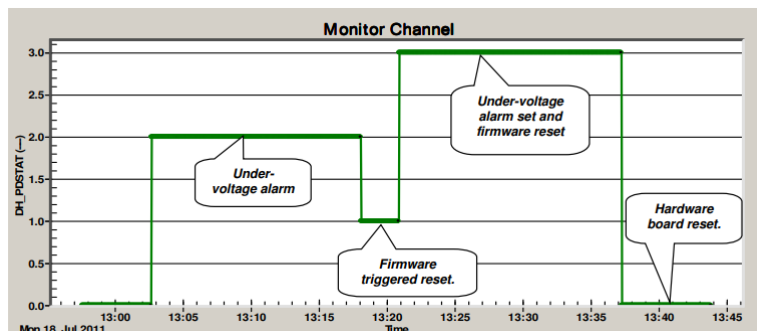
PD_STAT status word interpretation

If the DH_PD_STAT channel is being transmitted (it is also recorded by Babel Fish), it can be used to determine issues with PD transmission. Recorded memory from the Babel Fish can also be used to interpret issues with PowerDrive transmission from a variety of quality indicators after the run.

BIT	Meaning
0	System reset occurred under firmware control
1	This bit becomes set after an under voltage event occurred in P
2	Overcurrent alarm
3	The bit sets when ILink does not receive any data from PD controller board

Figure 14 shows example how DH_PDSTAT changes depending on PD control unit.
